# Manhole Inspection Summary

Manhole # S41G\_\_028MH

Insp Date: 11/3/08 3:17 PM

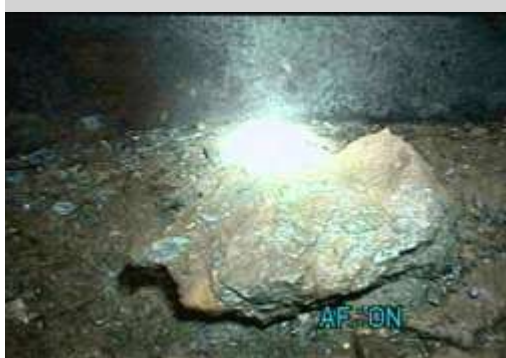
Defect 3

Condition: ☐ Sound ☐ Cracked ☐ Root Intrusion ☐ Deteriorated ☐ Leaks ☒ **Debris**

bench debris

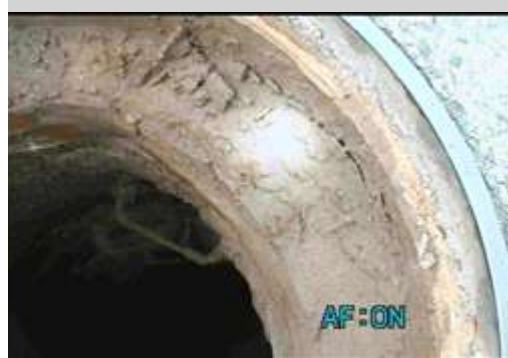
Defect 2

Offset: **4** (in.)

Infiltration: ☐ None ☒ **Joint** ☐ Cracks ☐ Mortar ☐ Roots ☐ Wall

frame offset, chimney joint infiltration

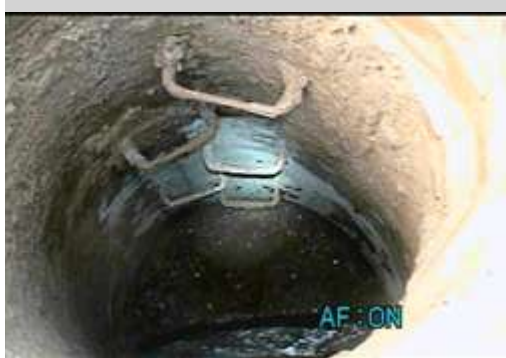
Defect 1

Count: **5** Missing: **0** ☒ **Corroded**

cor steps

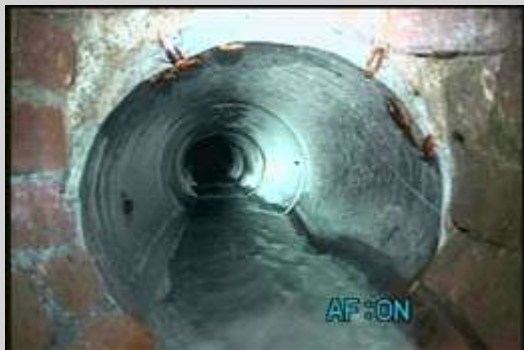
12 O'Clock Outflow

12 in. Circular Gravity Sewer  
Pipe Out @ 12 O'Clock

Pipe Material: **Clay** ☐ Pipe Lined

Invert Depth: **10.33** (ft.) Flow Characteristics: **Fast**

Deposits: ☒ None ☐ Mud ☐ Sludge ☐ Debris ☐ Grease

Infiltration: **None** Pipe Seal Cond: **Unknown**

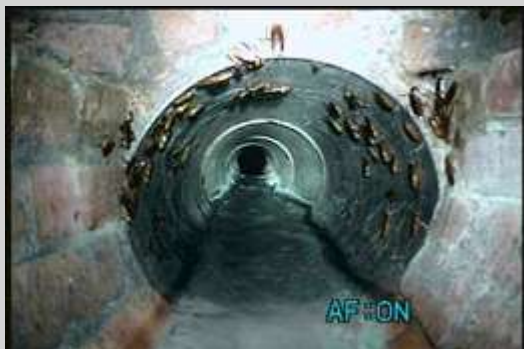
6 O'Clock Inflow

12 in. Circular Gravity Sewer  
Pipe In @ 6 O'Clock

Pipe Material: **Clay** ☐ Pipe Lined

Invert Depth: **10.25** (ft.) Flow Characteristics: **Fast**

Deposits: ☒ None ☐ Mud ☐ Sludge ☐ Debris ☐ Grease

Infiltration: **None** Pipe Seal Cond: **Unknown**

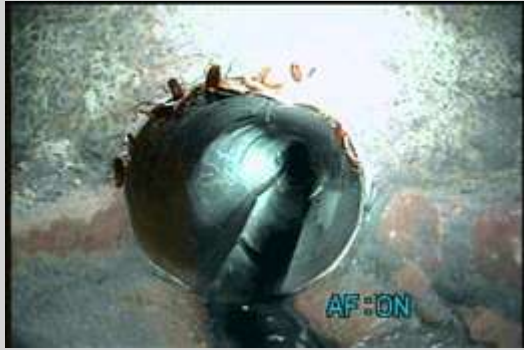
9 O'Clock Inflow

8 in. Circular Gravity Sewer

Pipe In @ 9 O'Clock

Pipe Material: **Clay** ☐ Pipe Lined

Invert Depth: **9.75** (ft.) Flow Characteristics: **None**

Deposits: ☒ None ☐ Mud ☐ Sludge ☐ Debris ☐ Grease

Infiltration: **None** Pipe Seal Cond: **Unknown**
